dsPIC33EPXXXGP50X, dsPIC33EPXXXMC20X/50X and PIC24EPXXXGP/MC20X

dsPIC33EPXXXGP50X, dsPIC33EPXXXMC20X/50X and PIC24EPXXXGP/MC20X Family Silicon Errata and Data Sheet Clarification

The dsPIC33EPXXXGP50X, dsPIC33EPXXXMC20X/50X and PIC24EPXXXGP/MC20X family devices that you have received conform functionally to the current Device Data Sheet (DS70657H), except for the anomalies described in this document.

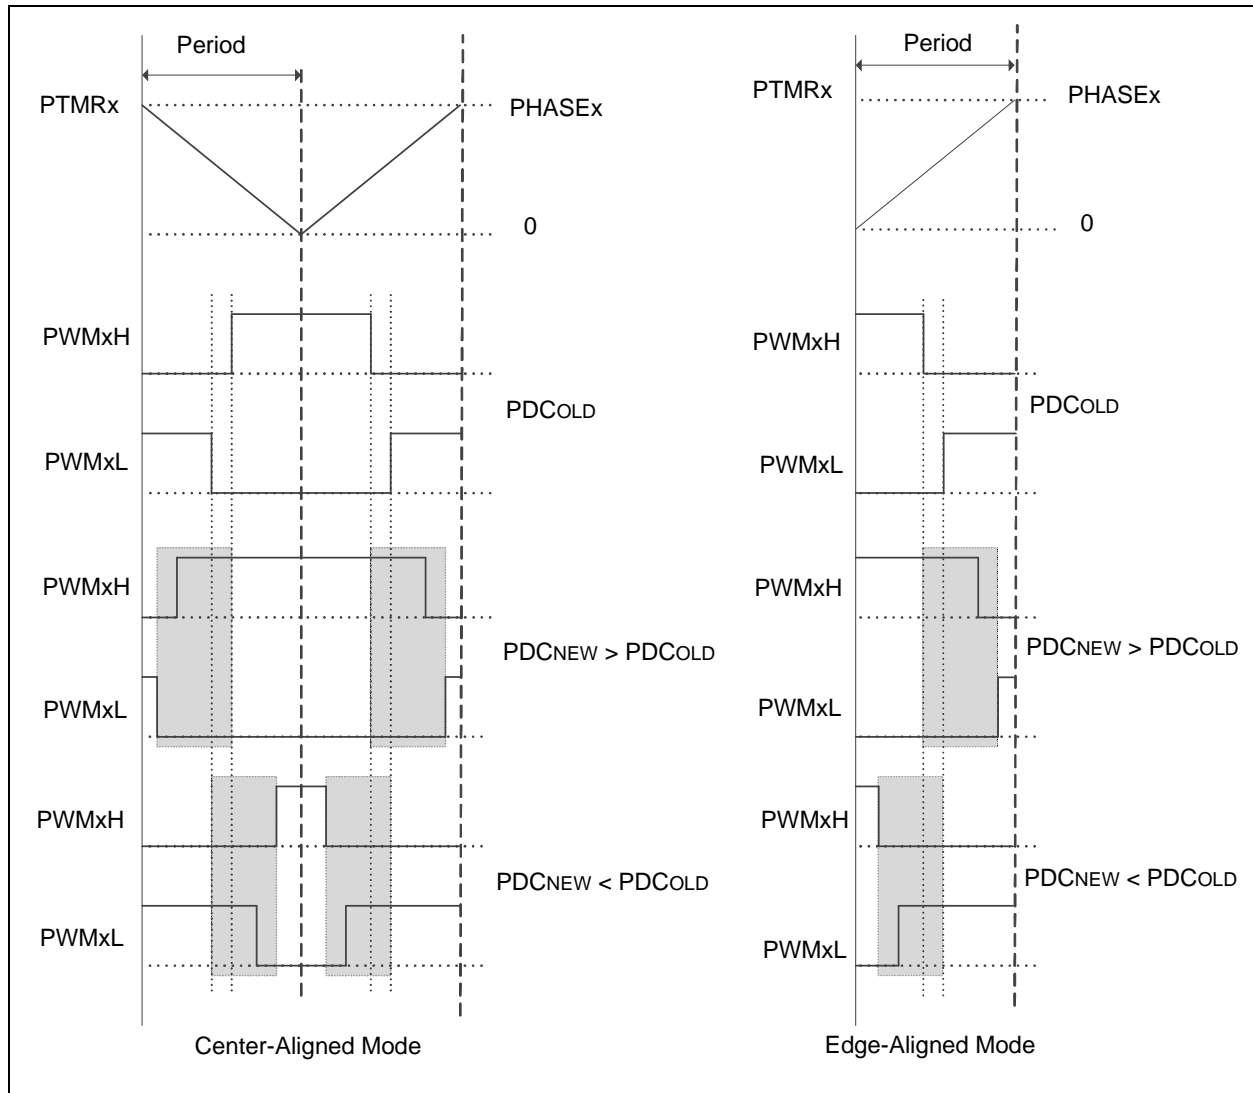
FIGURE 1-1: TIMING DIAGRAMS FOR CENTER-ALIGNED AND EDGE-ALIGNED MODES

The PWMx generator may not assert dead time on the edges of transitions. This has been observed when all of the following conditions are present:

In [Figure 1-1](#), if the duty cycle write occurred in the shaded box, then PWMxH and PWMxL will make an immediate transition without dead time.

None.

However, in most applications the duty cycle update timing can be controlled using the TRIGx trigger or special event trigger such that the above mentioned conditions are avoided altogether.

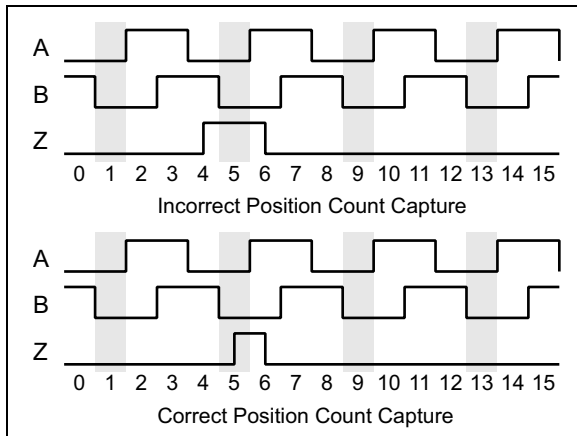
FIGURE 1-3: CORRECT AND INCORRECT POSITION COUNT CAPTURES

This is only observed when the leading edge of the index pulse occurs prior to the leading edge of the index match state. When the index pulse starts after the leading edge of the index match state, the position count is captured correctly.

Figure 1-3 shows how this occurs. In these cases, Encoder Signals A, B and (index) Z are shown, with the module being configured for index match when A and B are '0'. The effects of a correct and incorrect capture are shown side by side (shaded area indicates the index match state); the position count is shown along the bottom.

Work around

There are two different work arounds depending on the encoder type.

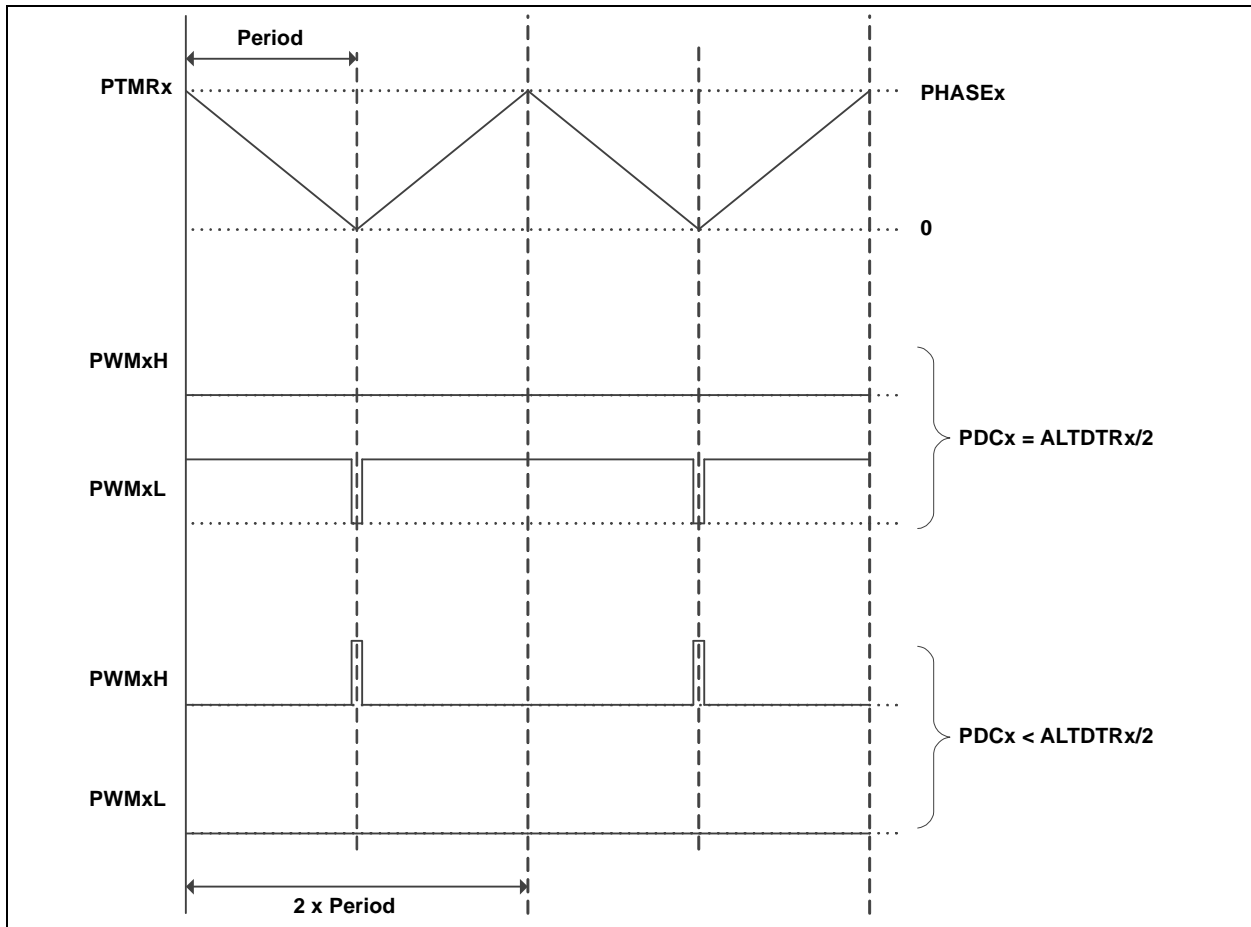
FIGURE 1-4: TIMING DIAGRAM

In Center-Aligned Complementary mode with Independent Time Base, if the value in the PDCx register is less than one-half the value in the ALTDTRx register, the PWMx generator will force the PWMxL to low and the PWMxH will generate pulses of width less than twice the dead time, as shown in Figure 1-4.

Work around

Include a software routine to ensure that the duty cycle value written to the PDCx register is always at least one-half of the value in ALTDTRx. Example 1-2 shows one method, with PDCtemp representing the variable which has the value to be written to the PDCx register. Alternatively, for duty cycle values less than half the desired dead time value, zero out the ALTDTRx register or dynamically reduce the value in the ALTDTRx register, such that ALTDTRx is always equal to 2 * PDCx, as shown in Example 1-3.
